Manhole Inspection Summary

Manhole # S43M__014MH

Location Address: **904 broadway st**

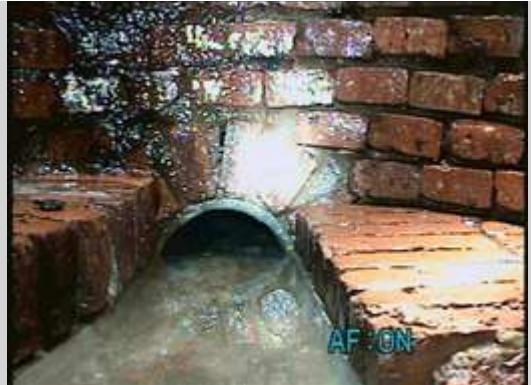
12 O'Clock Outflow

8 in. Circular Gravity Sewer
Pipe Out @ 12 O'Clock

Pipe Material: **Clay** ☐ Pipe Lined

Invert Depth: 10.00 (ft.) Flow Characteristics: **Fast**

Deposits: ☒ None ☐ Mud ☐ Sludge ☐ Debris ☐ Grease

Infiltration: **None** Pipe Seal Cond: **Unknown**

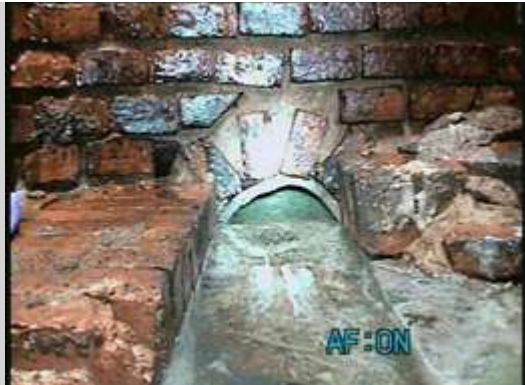
6 O'Clock Inflow

8 in. Circular Gravity Sewer

Pipe In @ 6 O'Clock

Pipe Material: **Clay** ☐ Pipe Lined

Invert Depth: **9.88** (ft.) Flow Characteristics: **Slow**

Deposits: ☒ None ☐ Mud ☐ Sludge ☐ Debris ☐ Grease

Infiltration: **None** Pipe Seal Cond: **Unknown**

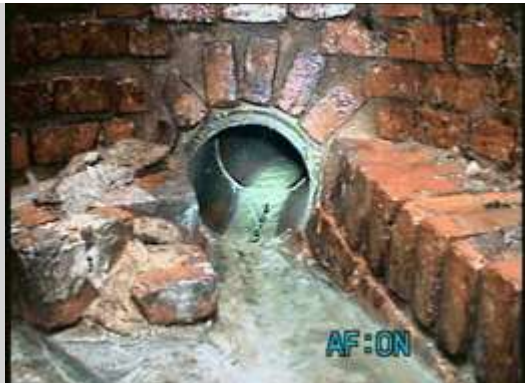
7 O'Clock Inflow

8 in. Circular Gravity Sewer

Pipe In @ 7 O'Clock

Pipe Material: **Clay** ☐ Pipe Lined

Infiltration: **None** Pipe Seal Cond: **Unknown**
